**Flood Control Project Maintenance
Levee Inspections**

Fall 2009 Levee Maintenance Deficiency Summary Report

Levee Inspection Report By Mile - Fall 2009

Sacramento Maintenance Yard Maintenance Area 0009

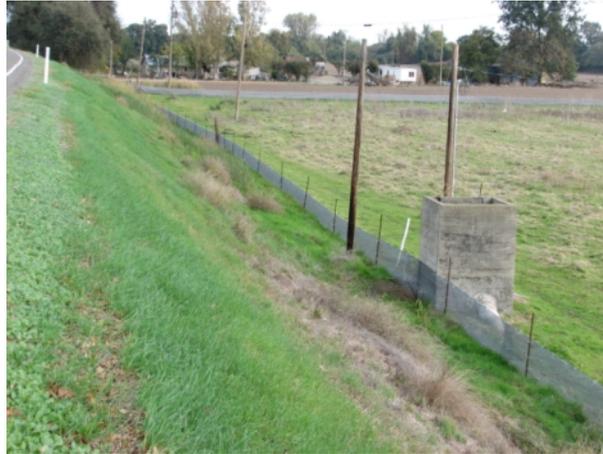
Levee Mile Report Line	193
Start Levee Mile	16.01
End Levee Mile	16.12
Location	Land Side
Category	Earthen Levee
Item	Encroachments
no permi for fence at toe	
johngw_f_20091209_087.jpg

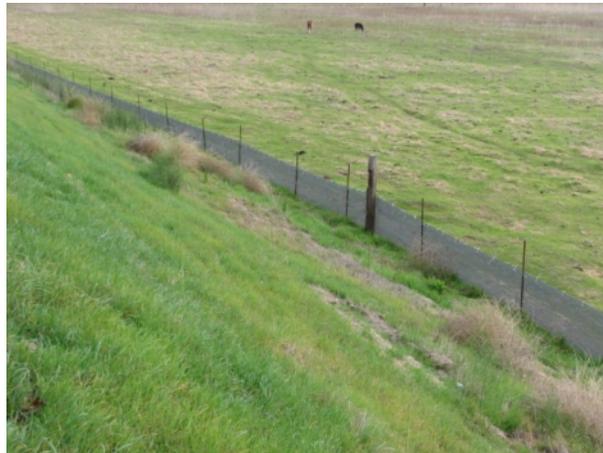
Levee Mile Report Line	196
Start Levee Mile	16.34
End Levee Mile	16.66
Location	Land Side
Category	Earthen Levee
Item	Encroachments
no permit for fence at toe	
johngw_f_20091209_088.jpg

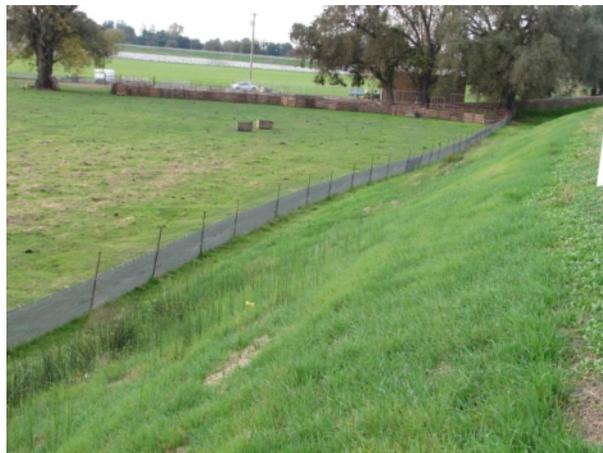
Levee Mile Report Line	196
Start Levee Mile	16.34
End Levee Mile	16.66
Location	Land Side
Category	Earthen Levee
Item	Encroachments
no permit for fence at toe	
johngw_f_20091209_089.jpg
